**Flood Control Project Maintenance  
Levee Inspections**

**Maintenance Issue Types Only, Levee Inspection Report By Mile - Fall 2016**

**Sacramento Maintenance Yard Sacramento Bypass**

Waterway	Bank	Unit Miles	Inspection Start/End	Inspector
Unit No. 01 Sacramento Bypass or North Levee	Right	1.74	10/13/2016 10/13/2016	Oleg Yakimov

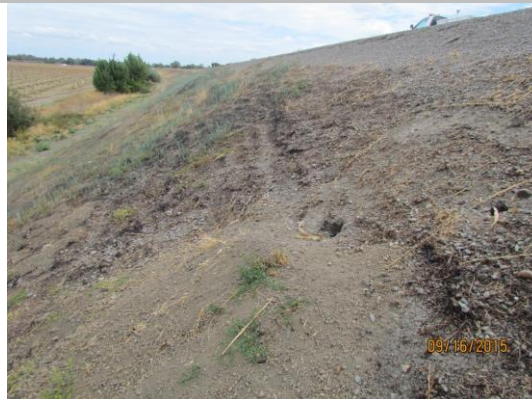
Photo 2 of 2 : FA\_2016\_ST0008\_284\_10\_20160913\_00001.jpg

LM Start	0.94	Rating **	M	Issue No.	10 (cont)	
LM End	0.94	Issue Type +	Ma	Location *	LS	
Category	Earthen Levee			GPS Latitude/Longitude		
				Start		End
Item	Animal Control			38.602763 °		38.602763 °
				-121.576288 °		-121.576288 °
DWR ID	DWR_ST0008_01_f_2015_10					
Comment Code						
A3 : No rodents visible, but rodent burrows visible; need to backfill and compact or grout burrows.						
Inspector Comment

View of the rodent holes on the landward side of the levee looking upstream. Fall 2015.

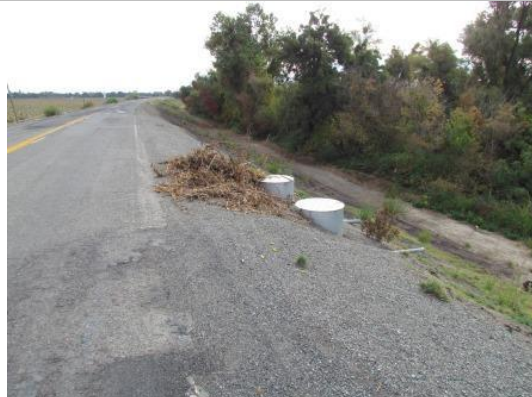
Photo 1 of 1 : FA\_2016\_ST0008\_284\_7\_20161013\_00010.jpg

LM Start	1.10	Rating **	M	Issue No.	7
LM End	1.10	Issue Type +	Ma	Location *	WS
Category	Earthen Levee			GPS Latitude/Longitude	
				Start	End
Item	Encroachments			38.602113°	38.602113°
				-121.579128°	-121.579128°
DWR ID	DWR_ST0008_01_f_2016_7				
Comment Code					
DE : Debris					
Inspector Comment

View of debris on WS slope of the levee. Fall 2016.

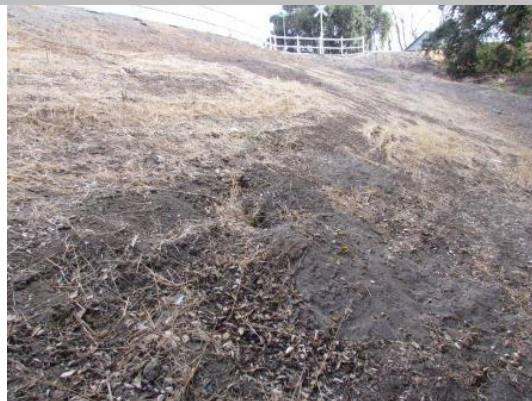
Photo 1 of 1 : FA\_2016\_ST0008\_285\_2\_20161013\_00002.jpg

LM Start	0.03	Rating **	M	Issue No.	2
LM End	0.03	Issue Type +	Ma	Location *	LS
Category	Earthen Levee			GPS Latitude/Longitude	
				Start	End
Item	Animal Control			38.602613 °	38.602613 °
				-121.556021 °	-121.556021 °
DWR ID	DWR_ST0008_02_s _ 2016_2				
Comment Code					
A3 : No rodents visible, but rodent burrows visible; need to backfill and compact or grout burrows.					
Inspector Comment

View of rodent holes on LS slope of the levee near entry gate. Fall 2016..

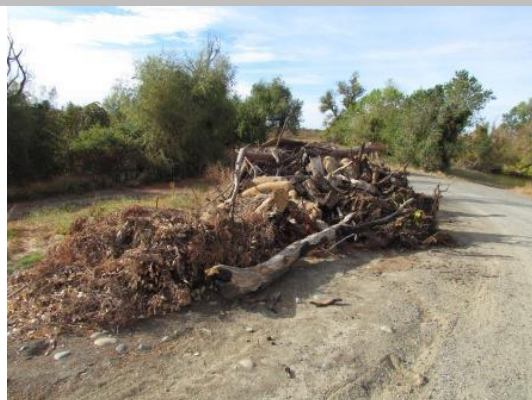
Photo 1 of 2 : FA\_2016\_ST0008\_285\_5\_20161013\_00003.jpg

LM Start	1.78	Rating **	M	Issue No.	5
LM End	1.78	Issue Type +	Ma	Location *	LS
Category	Earthen Levee			GPS Latitude/Longitude	
				Start	End
Item	Encroachments			38.594702 °	38.594702 °
				-121.586604 °	-121.586604 °
DWR ID	DWR_ST0008_02_s_2016_5				
Comment Code					
DE : Debris					
Inspector Comment					
This is a seasonal pile but gets burned by the LMA each year.

More debris was added to the pile since the time of last inspection. Fall 2016.

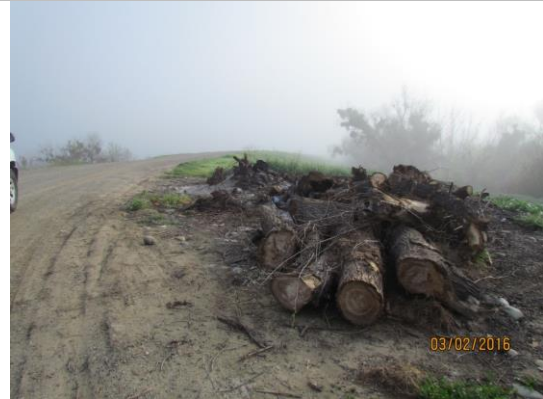
Photo 2 of 2 : FA\_2016\_ST0008\_285\_5\_20160913\_00001.jpg

LM Start	1.78	Rating **	M	Issue No.	5 (cont)	
LM End	1.78	Issue Type +	Ma	Location *	LS	
Category	Earthen Levee			GPS Latitude/Longitude		
				Start	End	
Item	Encroachments			38.594702°	38.594702°	
				-121.586604°	-121.586604°	
DWR ID	DWR_ST0008_02_s_2016_5					
Comment Code						
DE : Debris						
Inspector Comment						
This is a seasonal pile but gets burned by the LMA each year.

View of the firewood on the landward side of the levee looking upstream.  
Spring 2016.
